CONFIDENTIAL: Technical Report

Project FPD0006 Fire test Utilising the general principals of ASFP TGD19 (Nov 2017). Assessing a Tenmat Ventilert Brandstop Eaves Barrier with mesh spark arrester on the fire side of the barrier	
Report Date	10/12/2020
Author	Ian W. Hainsworth
Circulation	DR, MD, KC, CC, GB, PD

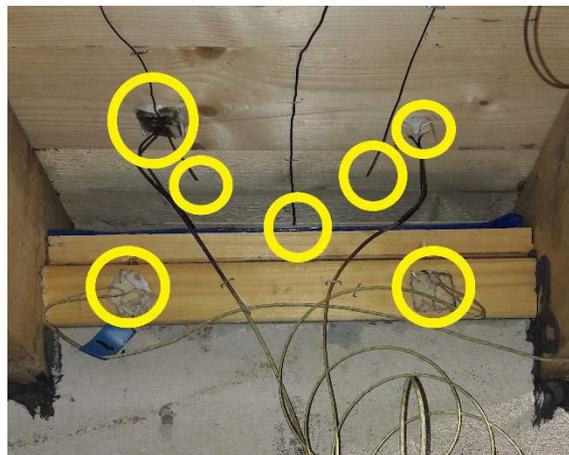
1. Surface – on rear of the wall plate left hand side, quarter of the distance in.
2. Surface – on rear of the wall plate right hand side, quarter of the distance in.
3. Surface – on underside of the roof boards left hand side, quarter of the distance in.
4. Surface – on underside of the roof boards right hand side, quarter of the distance in.
5. Suspended in the air cavity non-fire side, left hand side, quarter of the distance in and 25mm back from the fire barrier
6. Suspended in the air cavity non-fire side, left hand side, quarter of the distance in and 25mm back from the fire barrier
7. Suspended in the air cavity fire side, centrally positioned over the intumescent material, 10mm back from the fire side edge.
8. Furnace thermocouple

One extra suspended external thermocouple (No 7) placed at the upper central section of the barrier pad to monitor the temperature at the top of the intumescent, it was placed 10mm from the fire side of the material, this thermocouple is additional to the requirements of the test standard, and as such will play no part in the integrity or insulation results expressed in the findings of this test report.

Thermocouples shown in the picture below, indicated by the yellow circles.

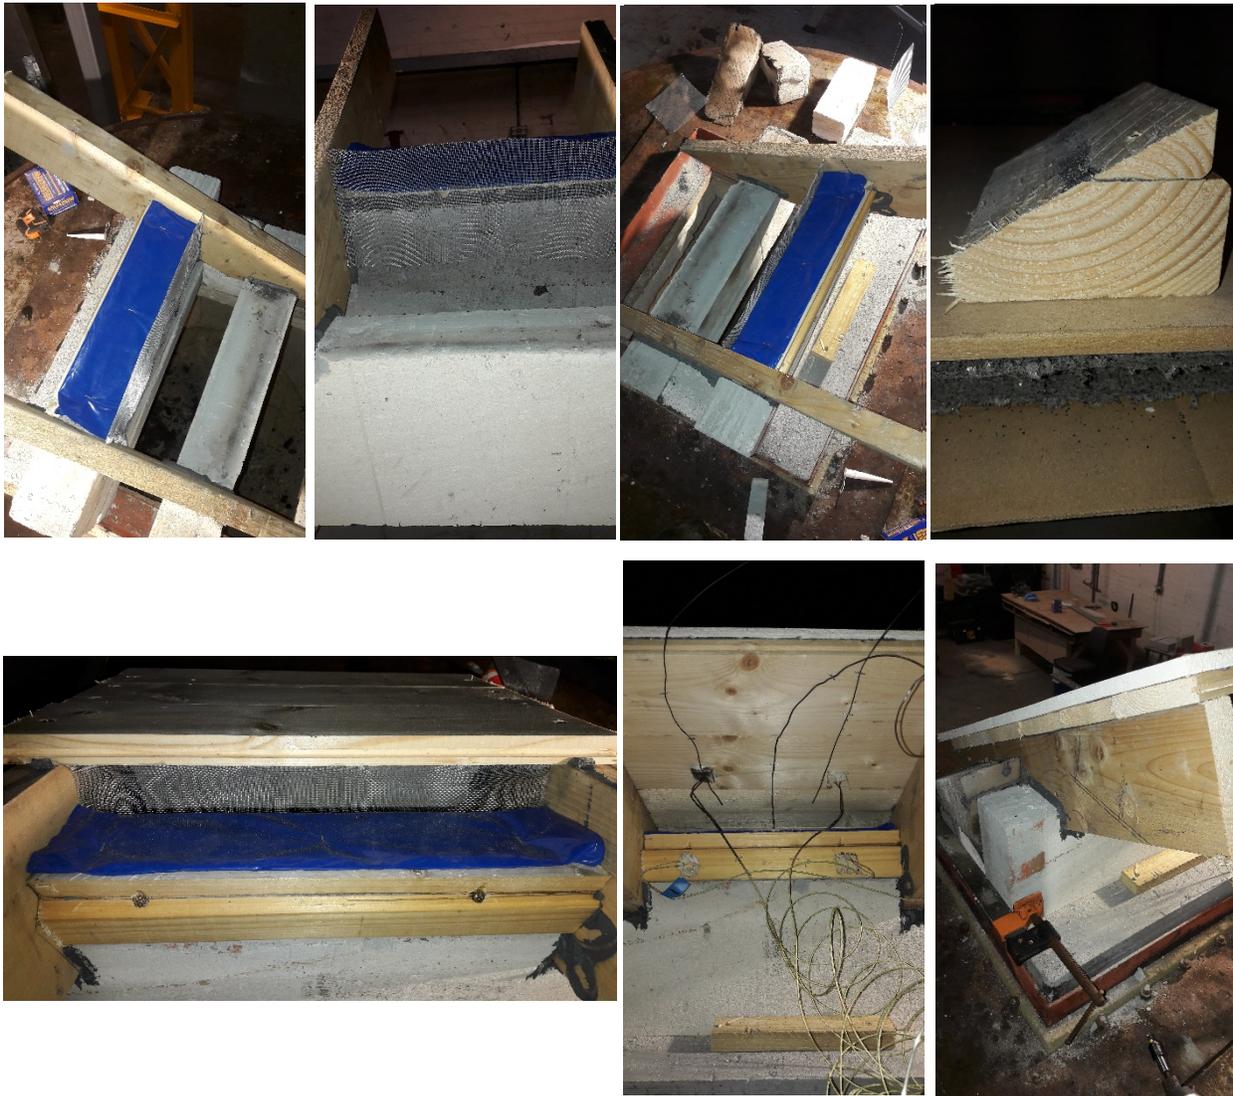
Images of the sample pre test

The test sample was fitted into a test rig comprising of a 630mm x 210mm x 100mm aerated concrete blocks to form a 430mm x 100mm wall cavity, two end blocks 100mm x 100mm x 215mm were placed as infill at the end to close off the remaining furnace opening, into and over this cavity was a section of timber roof, it comprised of 145mm x 35mm supporting timber bearers clad with 20mm tongue and groove (T&G) boarding this was over drawn with 15mm fire line board to prevent the exposed sections of the roof burning through and subsequently stopping the test prematurely, this was all housed and supported by the angle iron frame holding the test rig in place on the furnace, also preventing any movement of the blocks during the test.

A cavity size at the eaves of the roof of 50mm high x 450mm wide incorporating a sample of eaves barrier with a remaining air gap of 46mm from the top of the barrier on the wall plate to the underside of the T&G boarding, on the unexposed side of the Ventilerat Brandstop fire barrier, an aluminium spark arresting mesh was fitted to the fire side of the wall plate, this mesh measured 150mm high x 450mm wide, stapled into place using 10mm galvanised steel staples

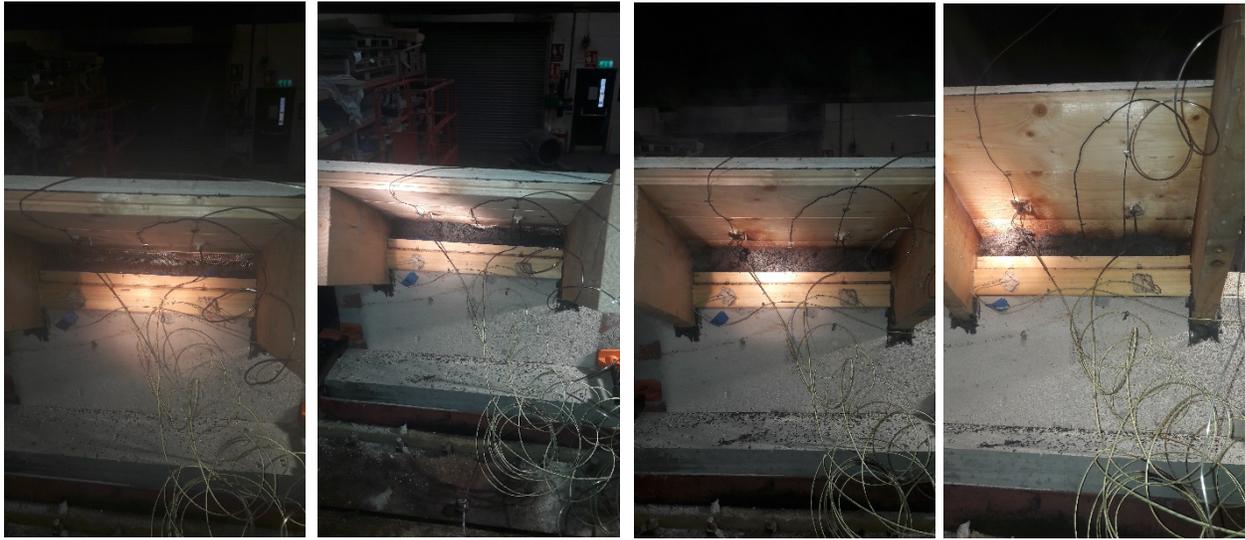
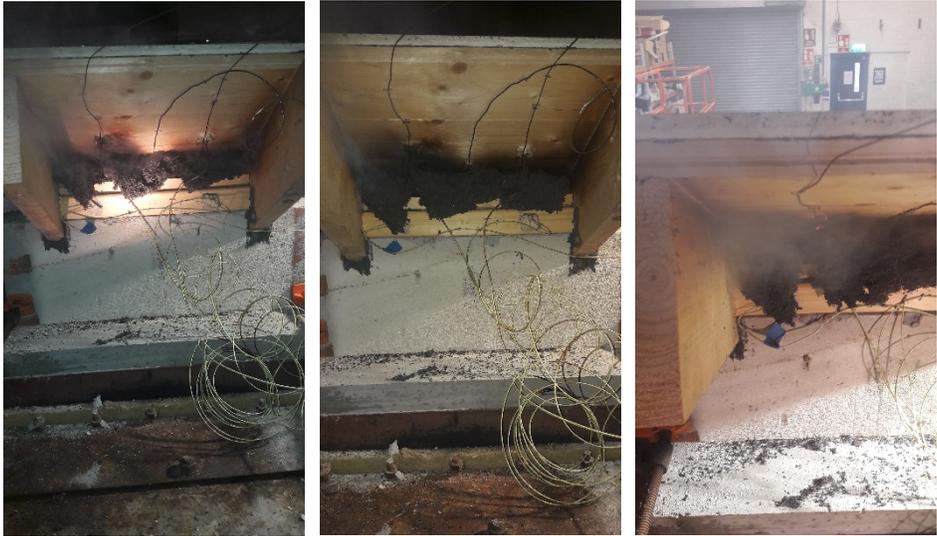
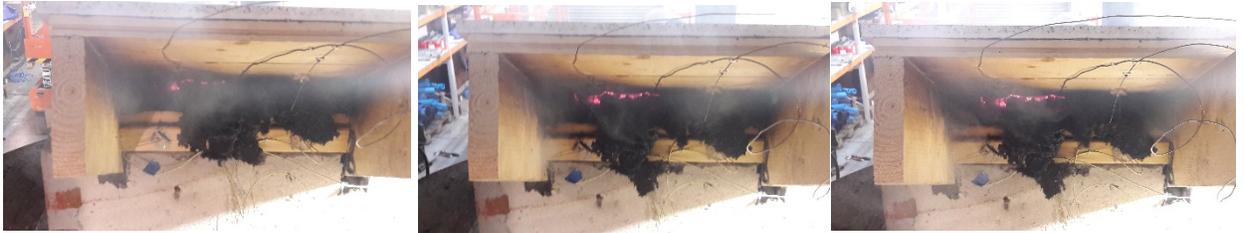
Images from the test

- 00 The test commences.
Plastic cover melts and shrinks away 15 seconds
- 01 FF102 intumescent material starting to react within the assembly.
- 02 50% closed off

- 03 Slight smoke from the test rig – 85% closed off, slight gap at right hand side of the barrier
- 04 85% closed off, slight gap at right hand side of the barrier starting to close off

- 05 4:15 95% closed – 4:45 100% closed off
- 06 No Change
- 07 No Change
- 08 No Change
- 09 No Change
- 10 Slight smoke
- 11 No Change
- 12 No Change
- 13 No Change

- 30 Movement of char stopped
- 31 No Change
- 32 Slight red glow at top centre of the char
- 33 No Change
- 34 Red Glow increasing
- 35 Red Glow increasing – Cotton pad applied, no ignition

- 42 Red Glow increasing – Visible thermal plumes observed - Cotton pad applied and ignited.
- 43 Test terminated

The test was run for 42 minutes at which time the top centre of the char lost integrity and active flaming was observed.

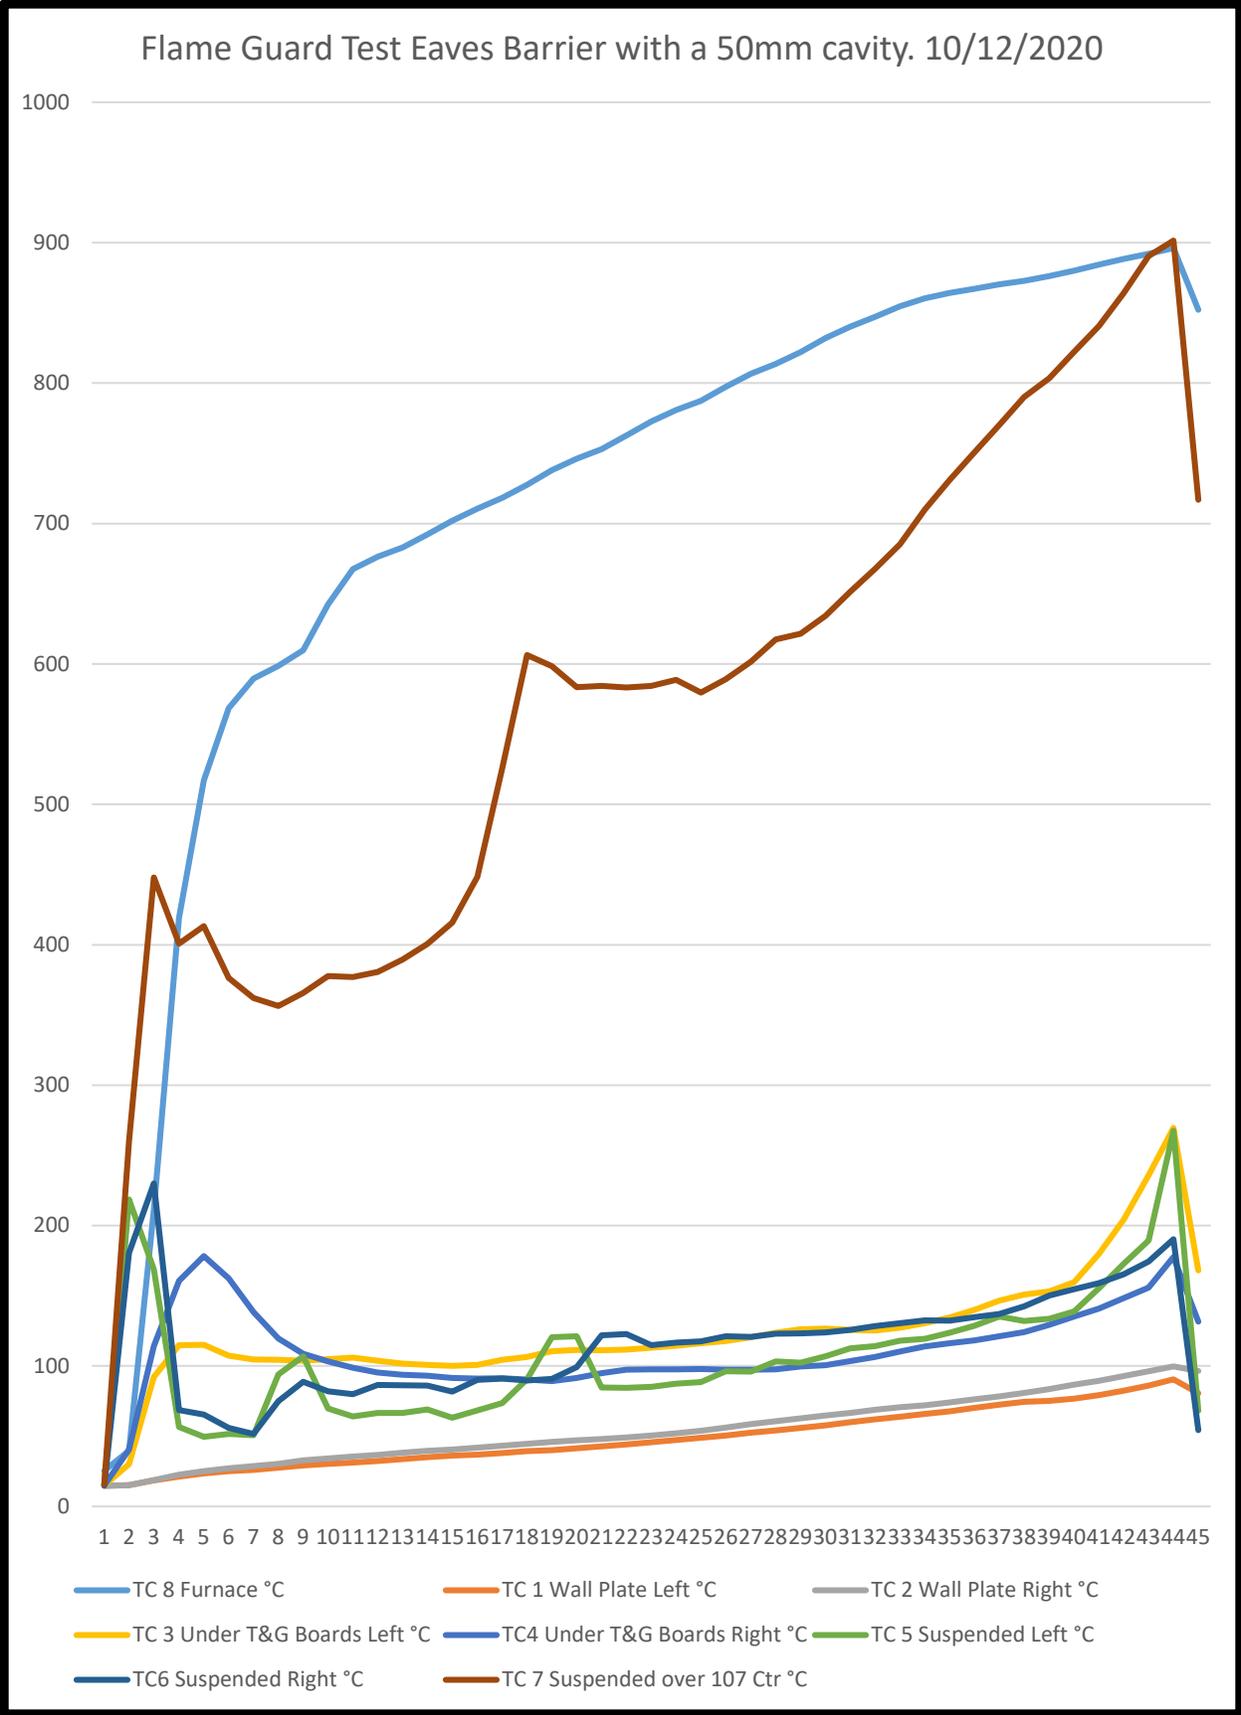
Temperature Readings Taken During the Test

- Insulation 40 minutes

- Closure time observed 4 minutes 50 seconds
- Thermocouple readings below 193 degrees - 2 minutes 50 seconds
