CONFIDENTIAL: Technical Report

Project FPD0006 Fire test Utilising the general principals of ASFP TGD19 (Nov 2017). Assessing a Tenmat Ventilert Brandstop Eaves Barrier with mesh spark arrester on the fire side of the barrier	
Report Date	10/12/2020
Author	Ian W. Hainsworth
Circulation	DR, MD, KC, CC, GB, PD

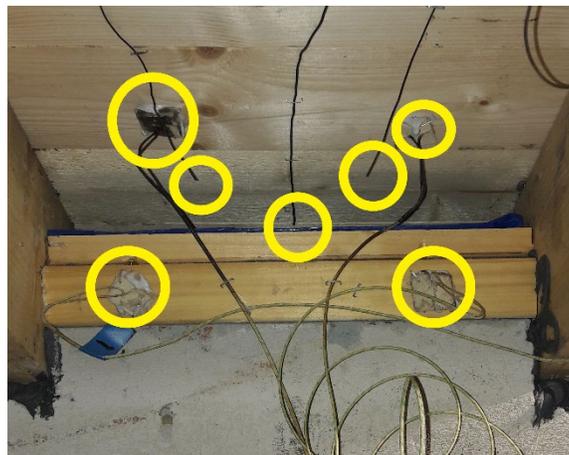
1. Surface – on rear of the wall plate left hand side, quarter of the distance in.
2. Surface – on rear of the wall plate right hand side, quarter of the distance in.
3. Surface – on underside of the roof boards left hand side, quarter of the distance in.
4. Surface – on underside of the roof boards right hand side, quarter of the distance in.
5. Suspended in the air cavity non-fire side, left hand side, quarter of the distance in and 25mm back from the fire barrier
6. Suspended in the air cavity non-fire side, left hand side, quarter of the distance in and 25mm back from the fire barrier
7. Suspended in the air cavity fire side, centrally positioned over the intumescent material, 10mm back from the fire side edge.
8. Furnace thermocouple

One extra suspended external thermocouple (No 7) placed at the upper central section of the barrier pad to monitor the temperature at the top of the intumescent, it was placed 10mm from the fire side of the material, this thermocouple is additional to the requirements of the test standard, and as such will play no part in the integrity or insulation results expressed in the findings of this test report.

Thermocouples shown in the picture below, indicated by the yellow circles.

The unexposed surface and suspended thermocouples were placed at the following locations: -

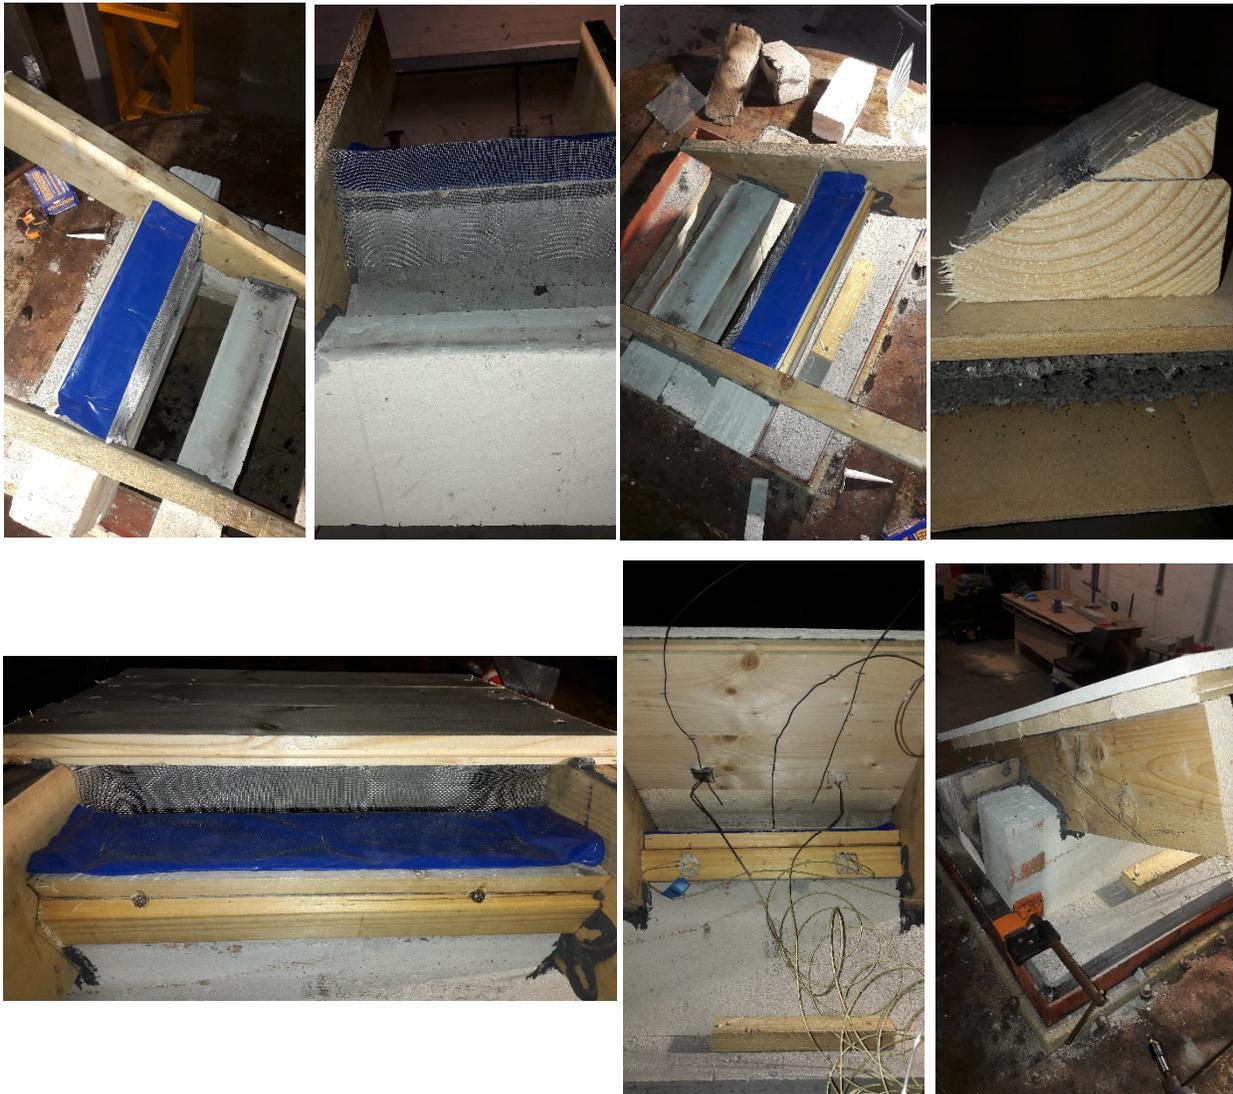
Images of the sample pre test

The test sample was fitted into a test rig comprising of a 630mm x 210mm x 100mm aerated concrete blocks to form a 430mm x 100mm wall cavity, two end blocks 100mm x 100mm x 215mm were placed as infill at the end to close off the remaining furnace opening, into and over this cavity was a section of timber roof, it comprised of 145mm x 35mm supporting timber bearers clad with 20mm tongue and groove (T&G) boarding this was over drawn with 15mm fire line board to prevent the exposed sections of the roof burning through and subsequently stopping the test prematurely, this was all housed and supported by the angle iron frame holding the test rig in place on the furnace, also preventing any movement of the blocks during the test.

A cavity size at the eaves of the roof of 50mm high x 450mm wide incorporating a sample of eaves barrier with a remaining air gap of 46mm from the top of the barrier on the wall plate to the underside of the T&G boarding, on the unexposed side of the Ventilert Brandstop fire barrier, an aluminium spark arresting mesh was fitted to the fire side of the wall plate, this mesh measured 150mm high x 450mm wide, stapled into place using 10mm galvanised steel staples

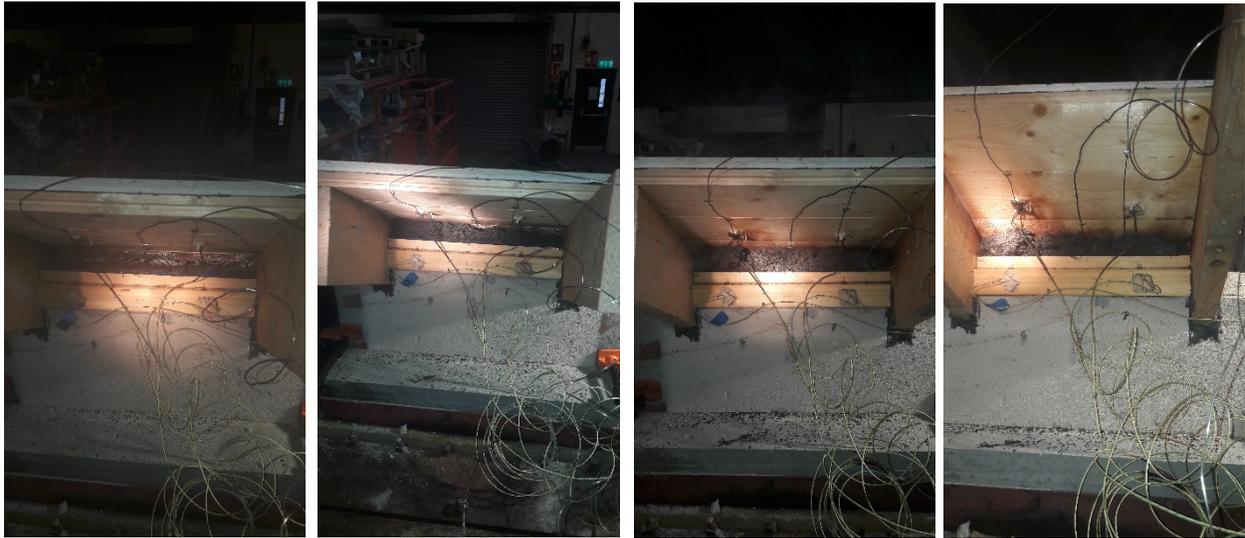
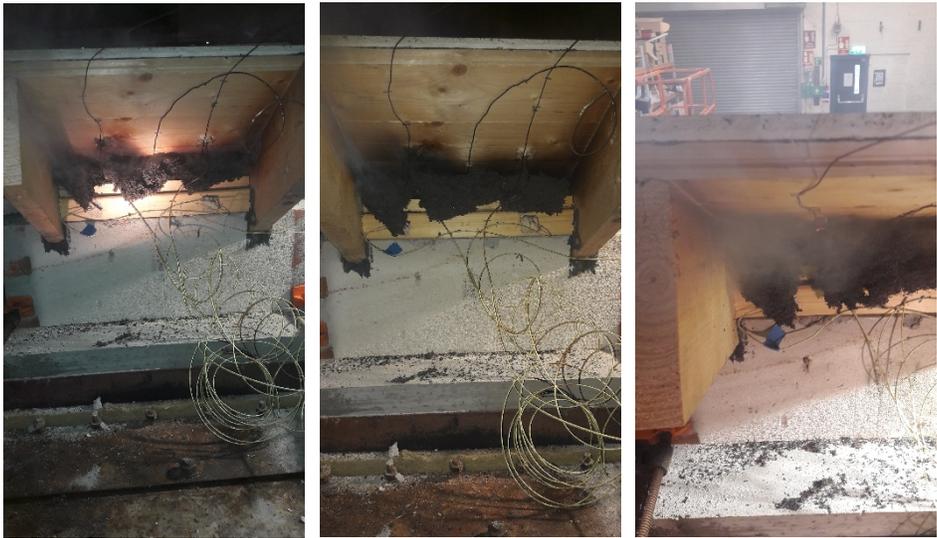
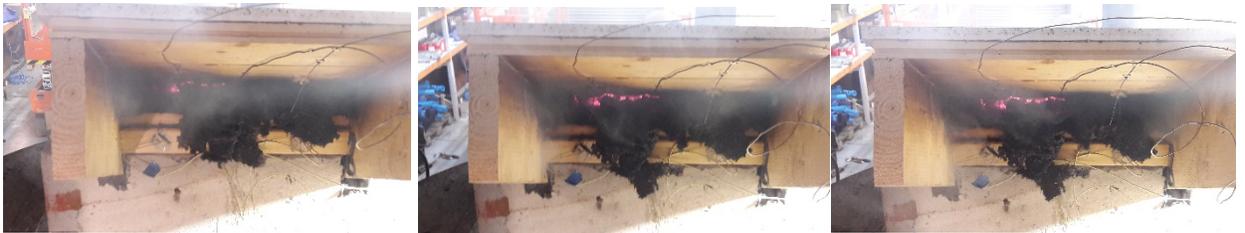
Images from the test

- 00 The test commences.
Plastic cover melts and shrinks away 15 seconds
- 01 FF102 intumescent material starting to react within the assembly.
- 02 50% closed off

- 03 Slight smoke from the test rig – 85% closed off, slight gap at right hand side of the barrier
- 04 85% closed off, slight gap at right hand side of the barrier starting to close off

- 05 4:15 95% closed – 4:45 100% closed off
- 06 No Change
- 07 No Change
- 08 No Change
- 09 No Change
- 10 Slight smoke
- 11 No Change
- 12 No Change
- 13 No Change

- 30 Movement of char stopped
- 31 No Change
- 32 Slight red glow at top centre of the char
- 33 No Change
- 34 Red Glow increasing
- 35 Red Glow increasing – Cotton pad applied, no ignition

- 36 Smoke increasing
- 37 Red Glow increasing towards centre of the rig
- 38 Red Glow increasing – Cotton pad applied, no ignition
- 39 No Change
- 40 Red Glow increasing – boards above glow starting to blacken from heat

- 42 Red Glow increasing – Visible thermal plumes observed - Cotton pad applied and ignited.
- 43 Test terminated

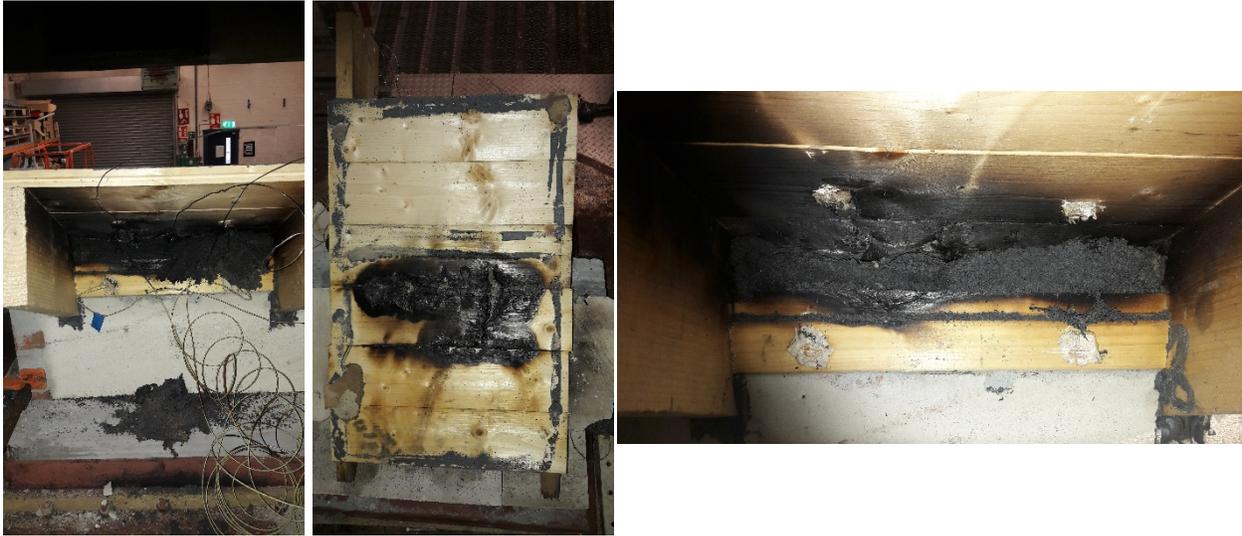
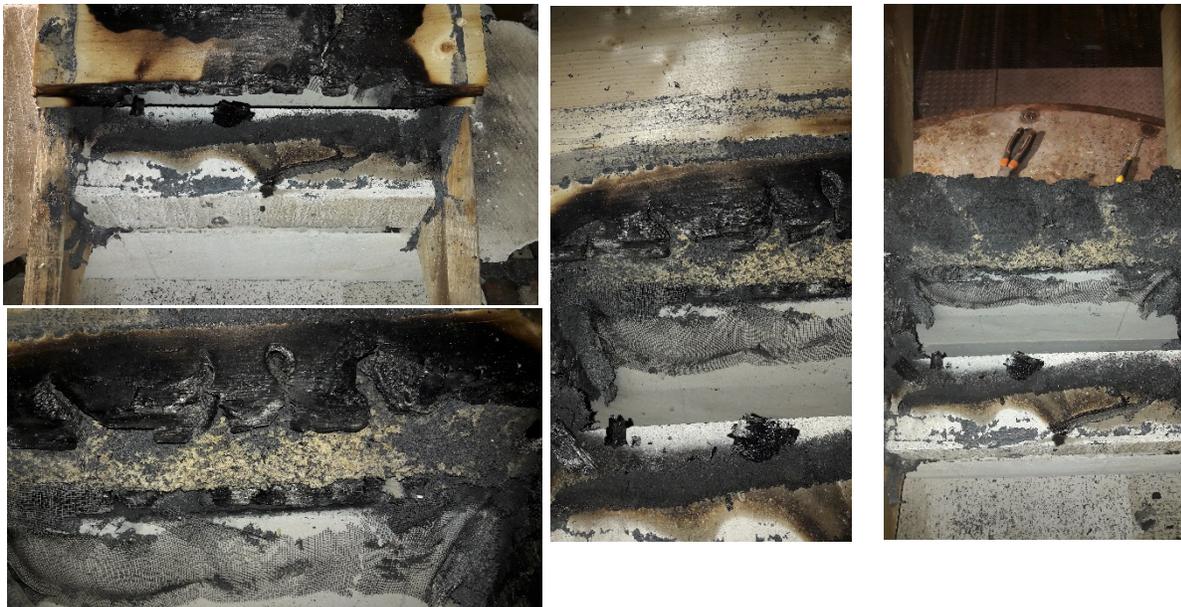
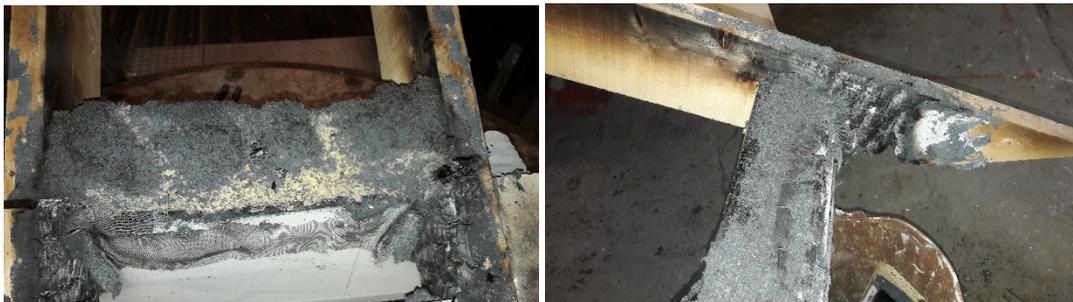
Test Sample Deconstruction

The test was run for 42 minutes at which time the top centre of the char lost integrity and active flaming was observed.

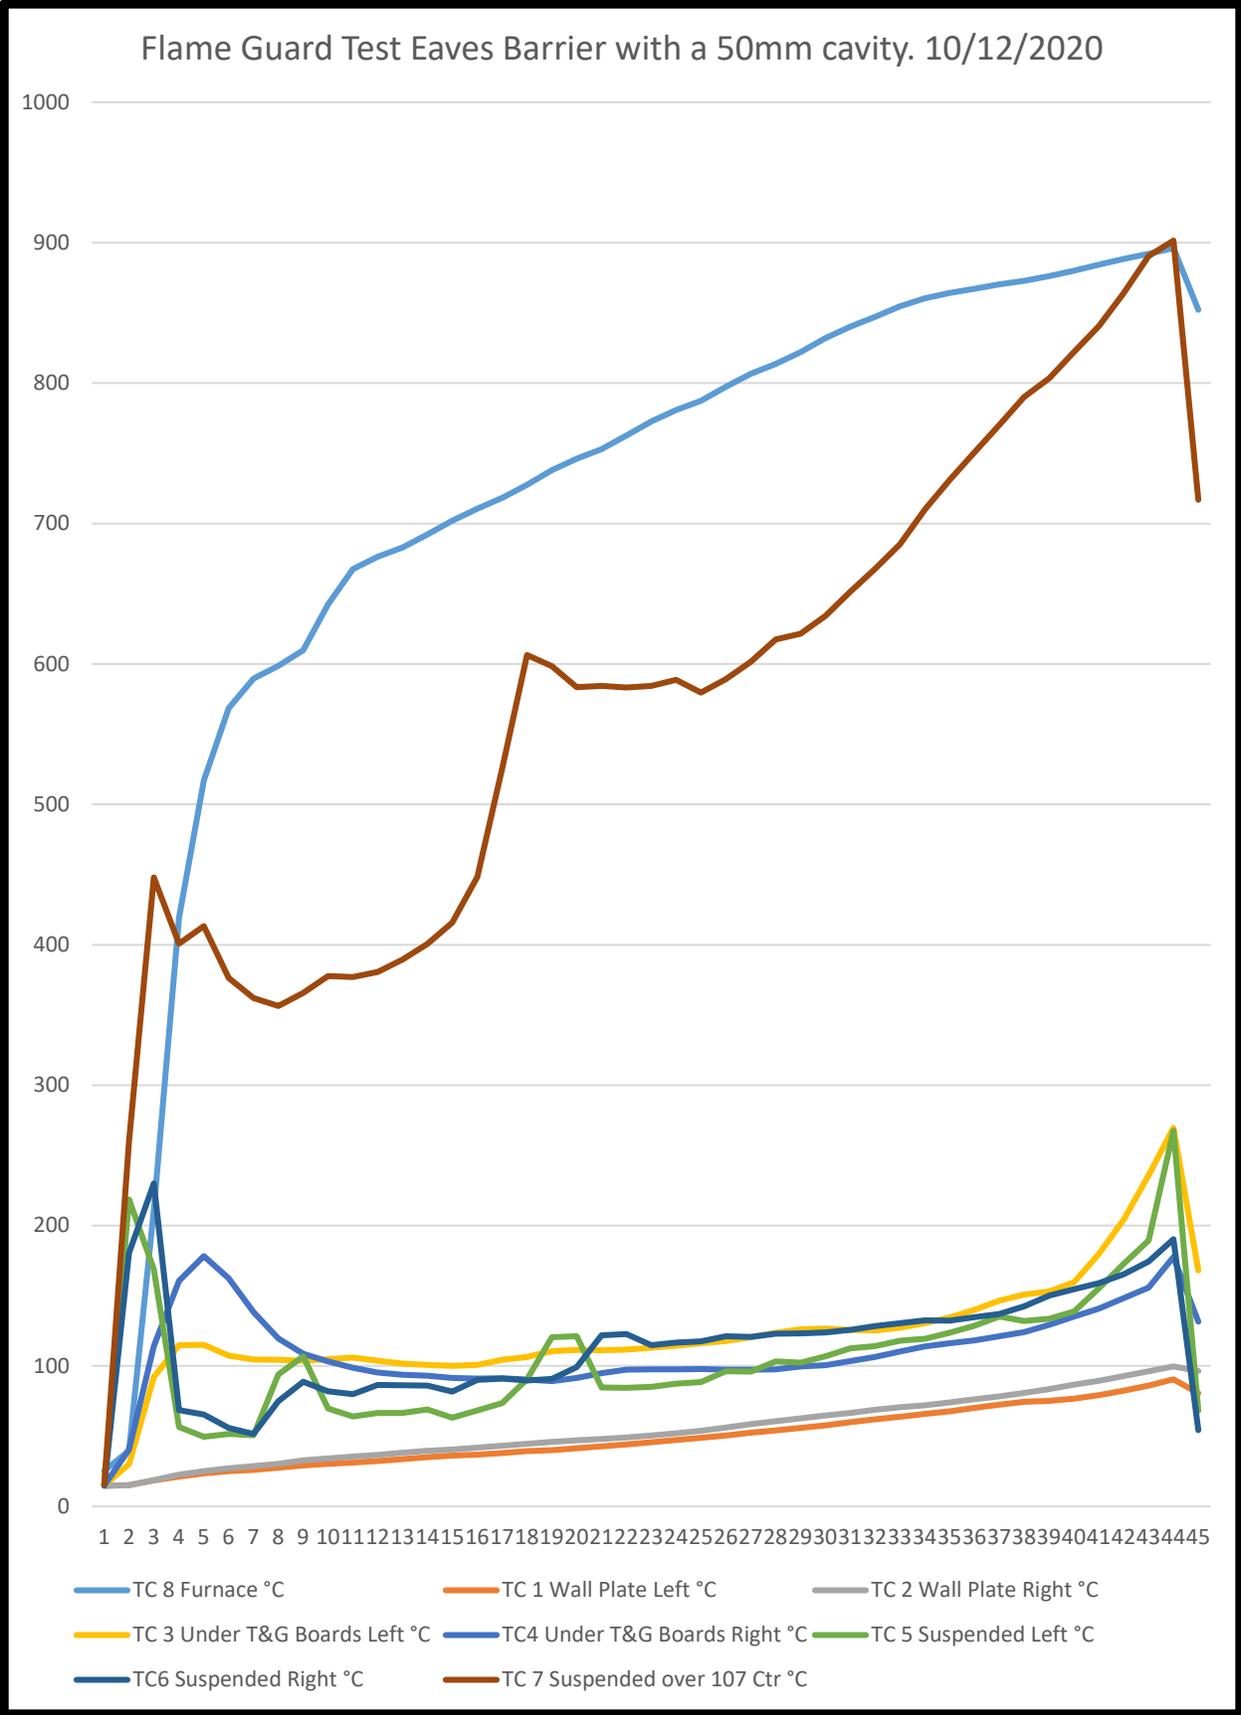
Temperature Readings Taken During the Test

Time	TC 8 Furnac e	TC 1 Wall Plate Left	TC 2 Wall Plate Right	TC 3 Under T&G Board s Left	TC4 Under T&G Board s Right	TC 5 Suspend ed Left	TC6 Suspend ed Right	TC 7 Suspend ed over 107 Ctr
Minute s	°C	°C	°C	°C	°C	°C	°C	°C
0	25.43	14.69	14.65	15.02	14.9	15.42	14.98	15.66
1	39.7	15.23	15.11	30.04	40.6	218.51	180.62	260.1
2	211.35	18.57	18.84	92.25	114.18	168.79	230.05	447.86
3	419.16	21.28	22.69	114.79	160.58	56.6	68.72	400.72
4	517.11	23.59	25.04	115.03	178.29	49.65	65.55	413.28
5	568.47	25.16	27.18	107.28	162.36	51.63	56	376.3
6	589.45	26.02	28.63	104.61	138.45	50.74	51.69	362.08
7	598.57	27.51	30.38	104.48	119.7	94.07	74.9	356.44
8	609.75	29.19	32.72	103.78	108.64	106.98	88.78	365.73
9	642.35	30.43	34.26	104.94	103.28	69.7	82.01	377.67
10	667.42	31.32	35.62	106.05	98.74	64.08	79.87	376.93
11	676.41	32.43	36.6	103.68	95.39	66.55	86.6	380.64
12	682.88	33.74	38.27	101.69	93.82	66.47	86.29	389.54
13	692.13	35.02	39.57	100.88	93.06	69.12	86.16	400.53
